Isle and Hasse Lakes Fisheries Restoration

Backgrounder:

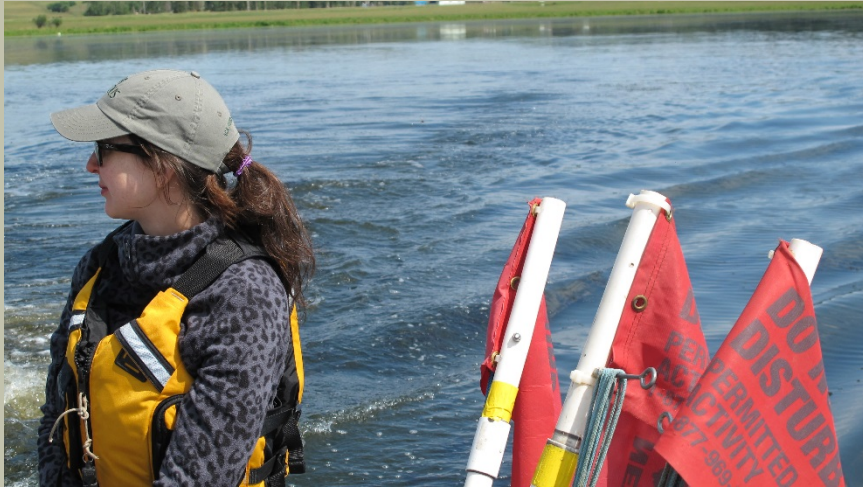
Isle Lake Test Net Catch Summary

2015 Test Netting Results

- “Pleasantly Shocked”
 - suspended netting after one day, based on catch and with confidence we had a snapshot of the current community

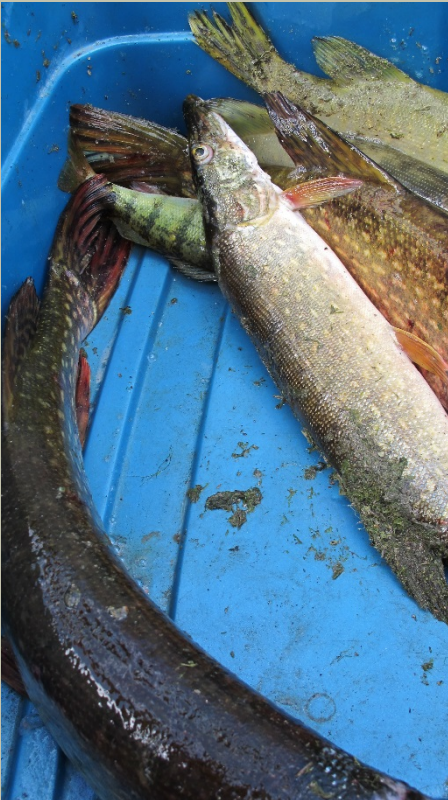
- Some (more) questions... potential answers?
 - Most fish were large

Northern Pike		
	length (mm)	weight (g)
min	388	375
max	803	3364
avg	604	1527
	length (in)	weight (lb)
min	15	0.8
max	32	7.4
avg	24	3.4

Walleye		
	length (mm)	weight (g)
min	565	1737
max	622	2550
average	589	2045.25
	length (in)	weight (lb)
min	22	3.8
max	25	5.6
average	23	4.5

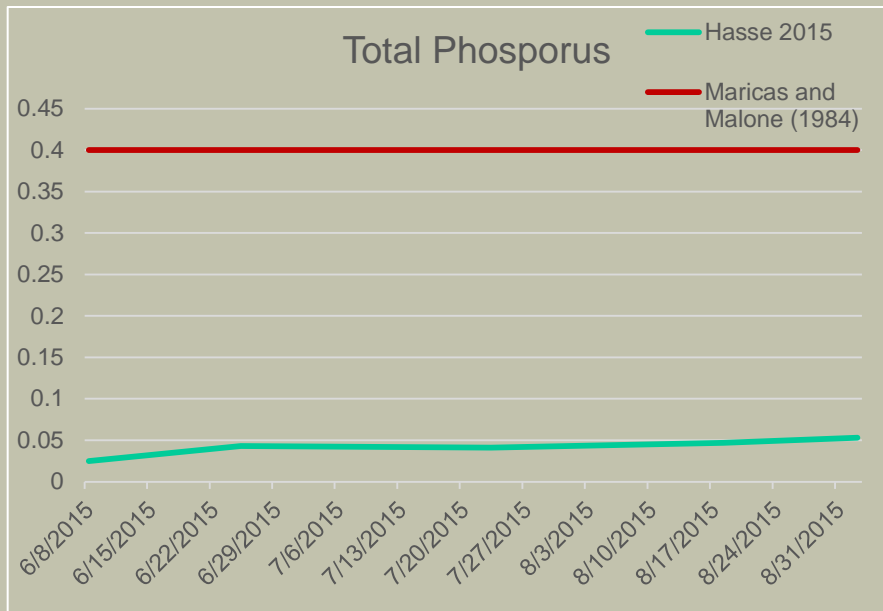
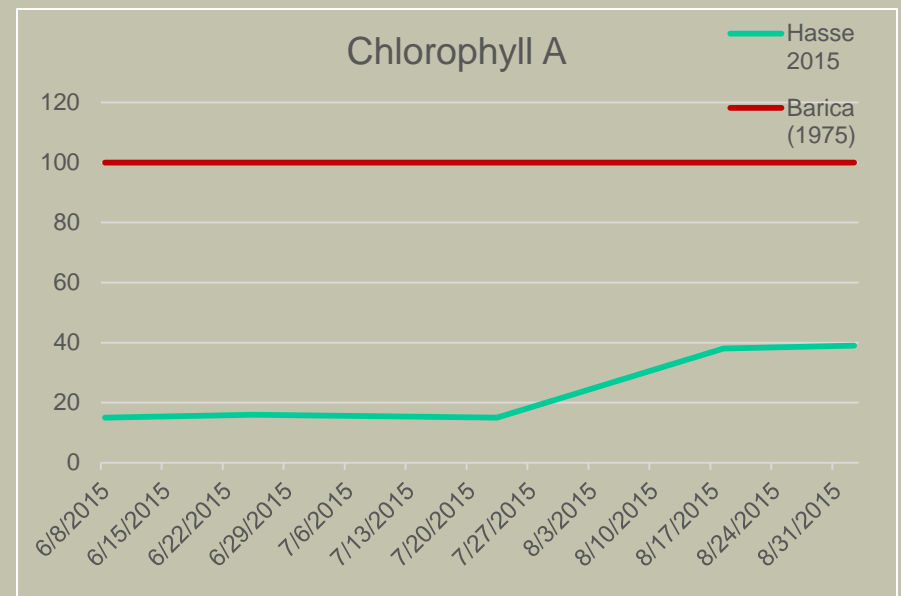
Hasse Lake Water Quality

- What did we see?

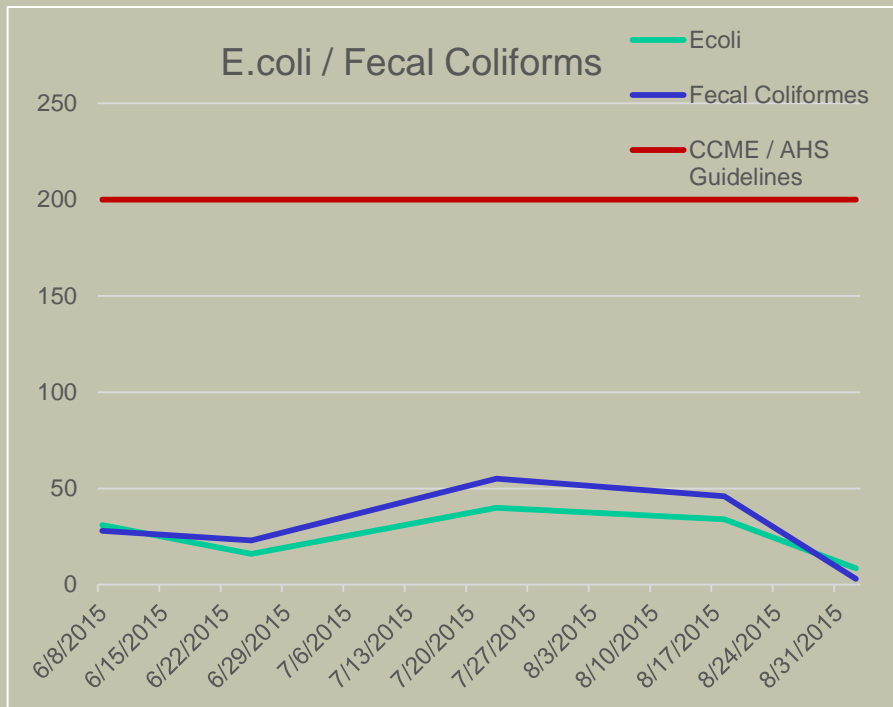
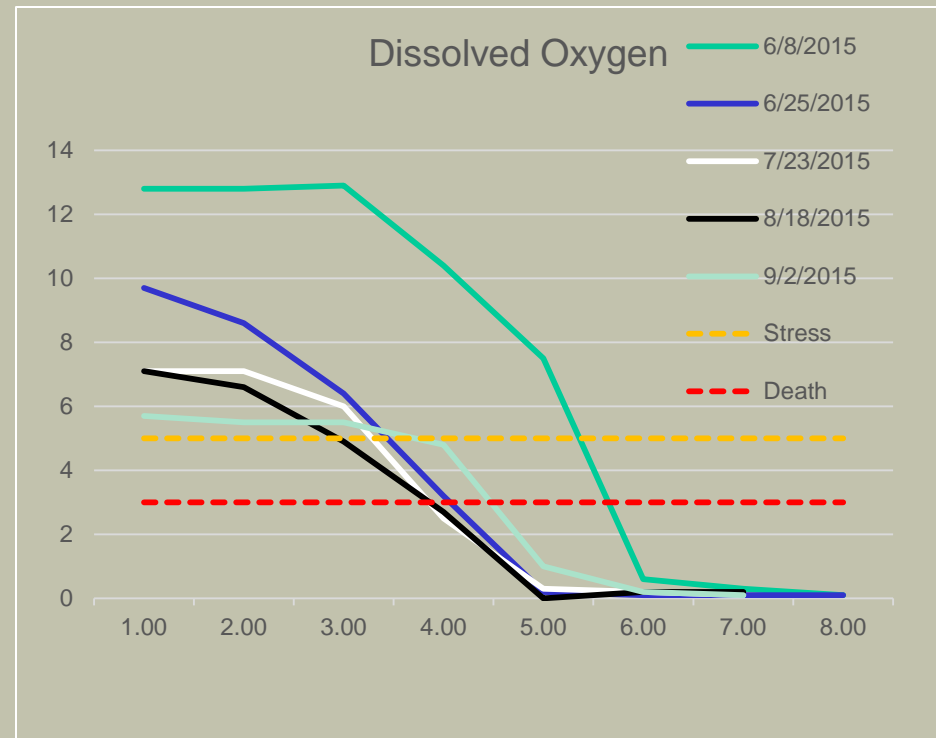
Hasse Lake Water Quality

- What did we see?
