WABAMUN WATERSHED
MANAGEMENT COUNCIL

Wabamun Lake Bulrush Restoration

September 13, 2023

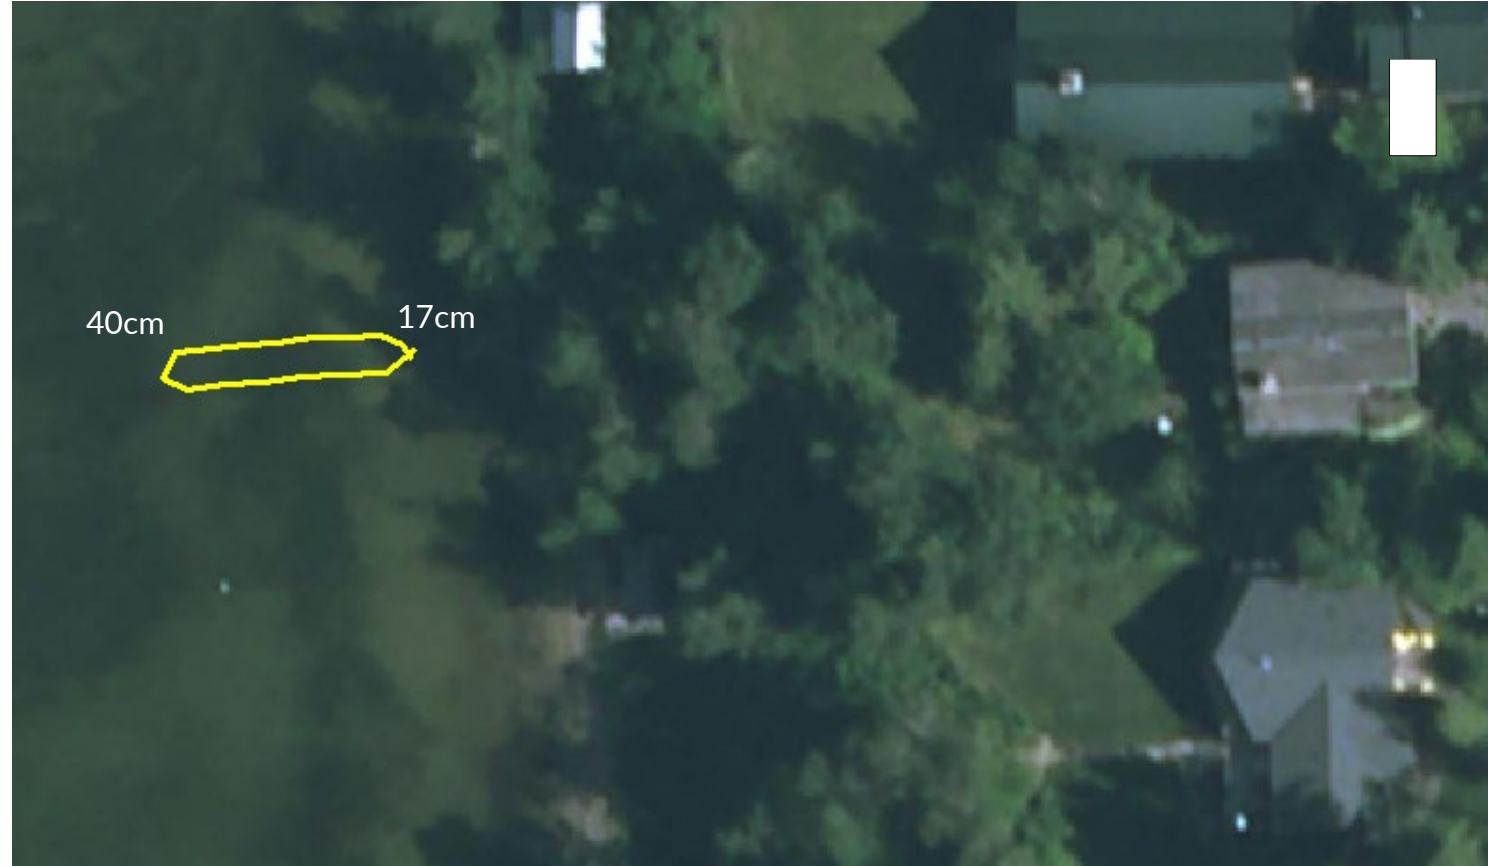
Site 1

- Wild harvest from site planted in deepest area (~50 x 1 gallon pot sized)
- 45 x 4 inch plugs of native bulrush
- 150 x 150cc green house plugs in area closest to shore
- ~43m² of area planted

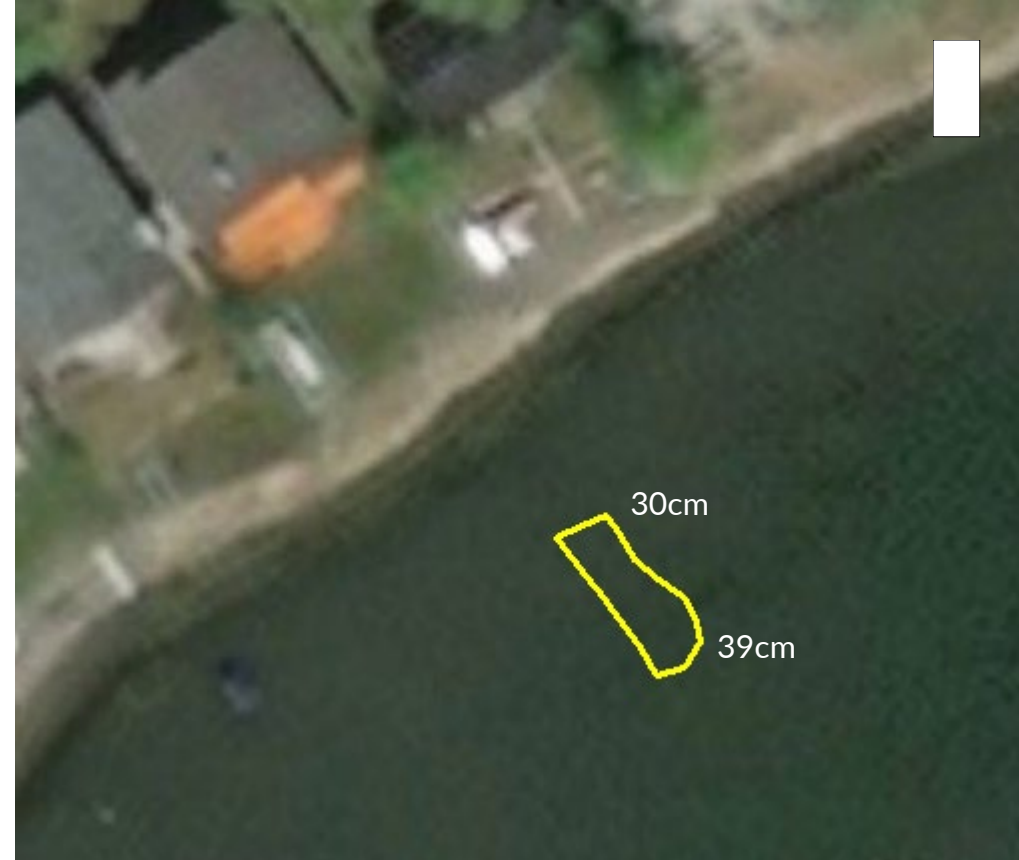
Site 2

- Wild harvest from site planted in deepest area
- 30 x 4 inch plugs of native bulrush
- 100 x 150cc green house plugs in area closest to shore
- ~41m² of area planted

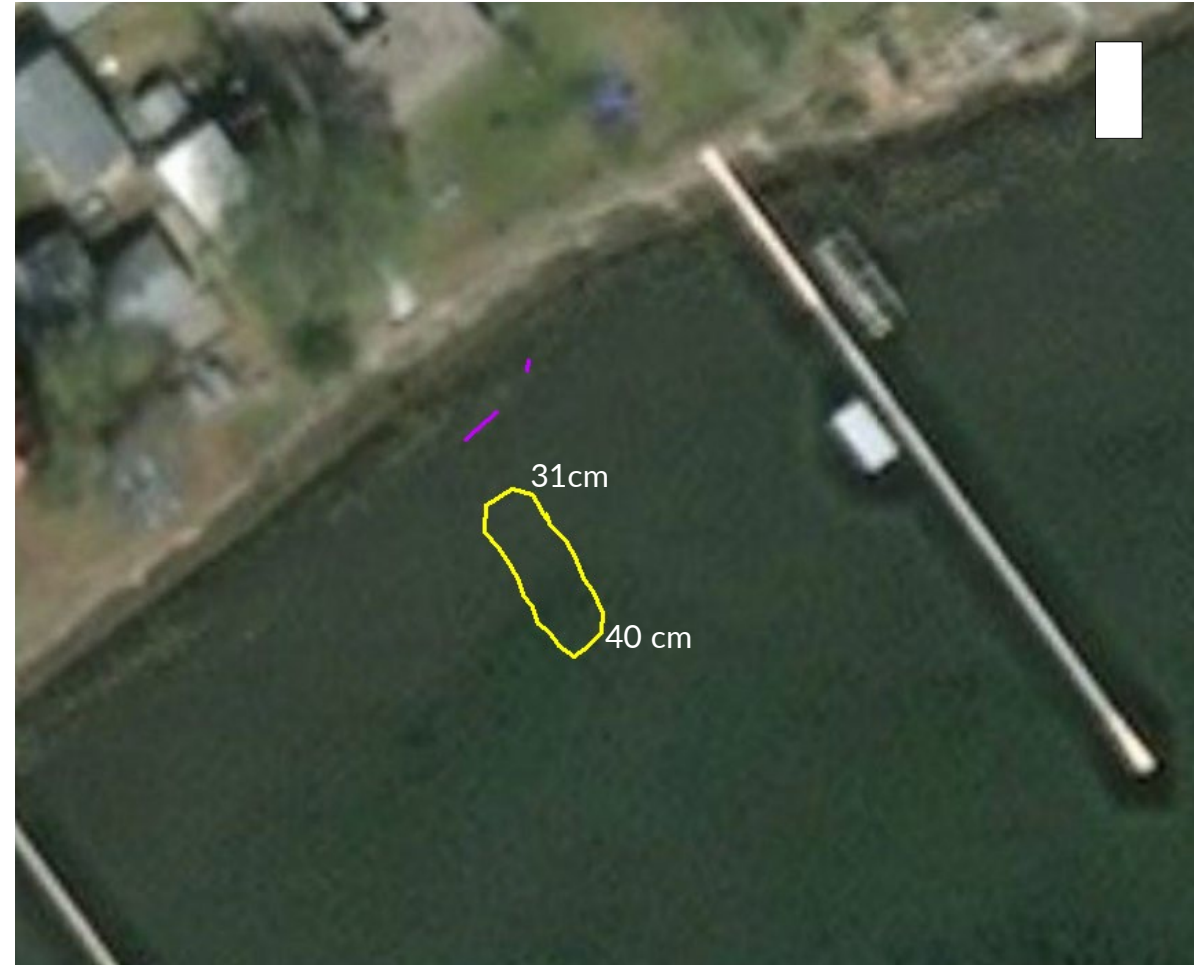
Site 3

- Wild harvest from site planted in deepest area
- 60 x 4 inch plugs of native bulrush
- 200 green house plugs in area closest to shore
- 30 Soft stem Bulrush planted along shoreline (seen in purple)
- ~57m² of Hardstem bulrush planted

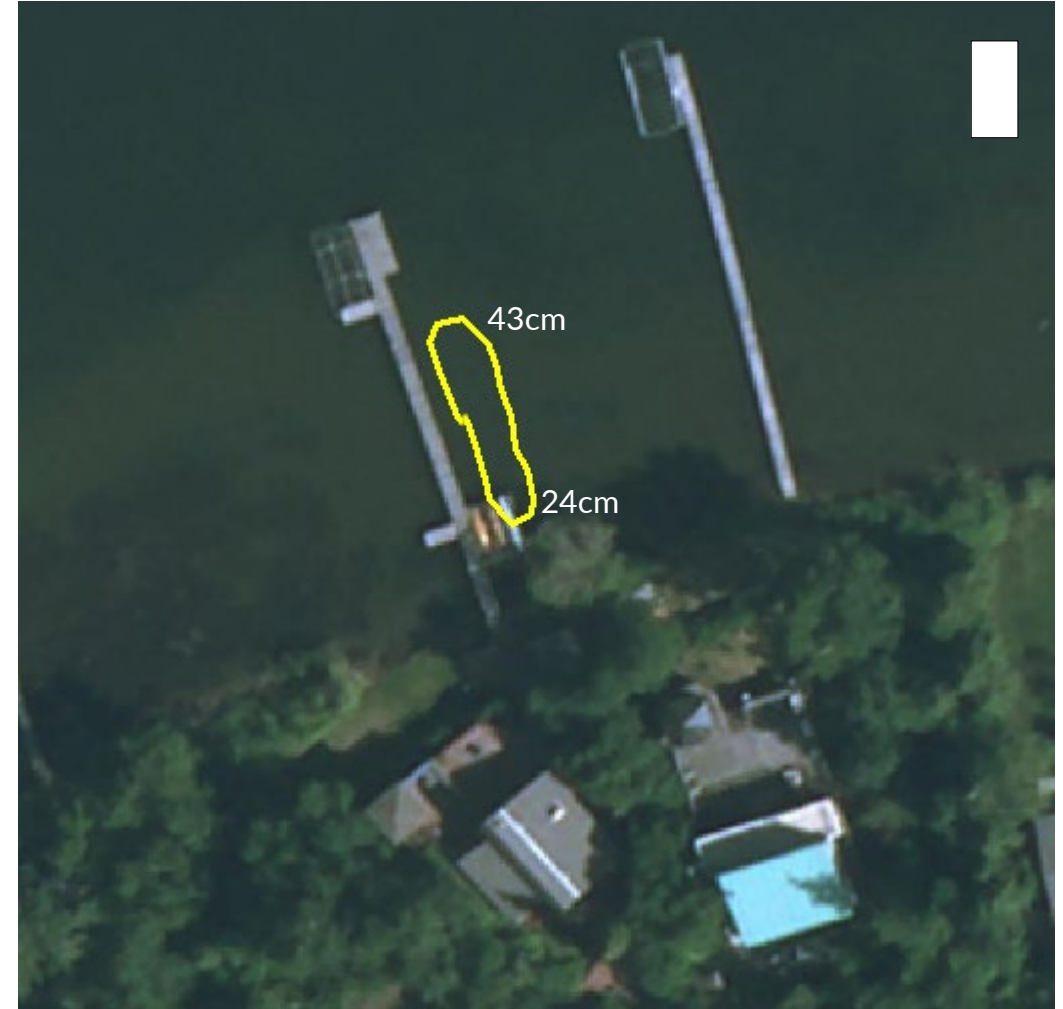
Site 4

- Water depths of area planted ranged from 24-43cm
- Wild harvest from site planted in deepest area
- 60 x 4 inch plugs of native bulrush
- 10 x 1 gallon green house plugs in area closest to shore
- ~59m² of area planted
