Riparian Area Intactness Assessment

Buffalo, Gull, Pigeon and Sylvan Lakes

Arin MacFarlane Dyer, Integrated Resource Planner September 28, 2018

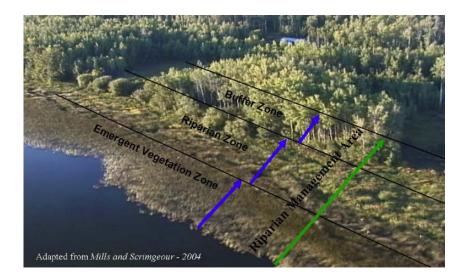
2007/08 Aerial Assessment

• The area of interest where management activities are focused to address negative impacts. Includes shoreline emergent vegetation zones and a protective buffer zone.

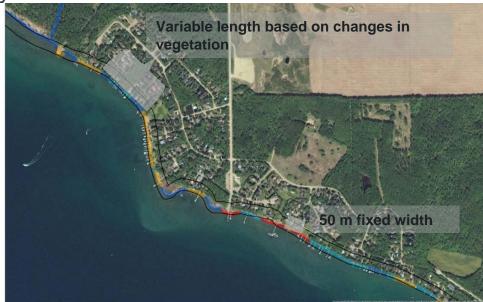
- 1. Approach based upon videography method and metrics
- 2. Riparian management areas (RMA) were created and used as the unit of analysis

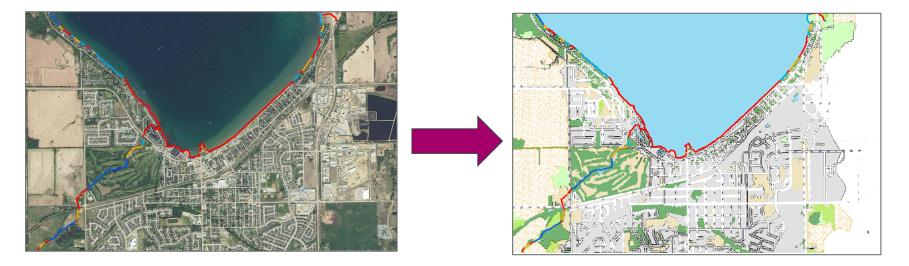
3. High resolution (6m) SPOT Satellite Imagery obtained for 2017

4. Spot imagery is converted to a landcover

- 5. Intactness calculated per RMA based on:
 - % cover all natural vegetation (wetlands, shrubs, grassland, forests)
 - % cover woody vegetation (forest)
 - % cover all human impact and development (crops, pasture, disturbed, houses, lawn, roads, ditches)
- 6. Scores for each metric aggregated into a single score that was then assigned to an intactness category.

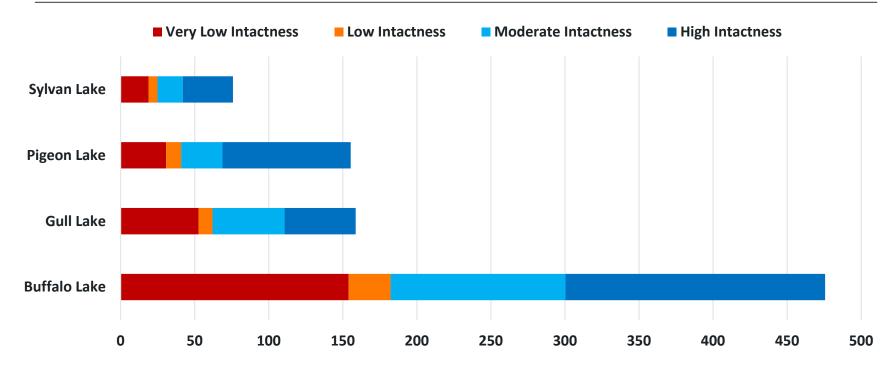
Watershed Results

Length (km) of Shoreline Assessed

- Majority of riparian management areas in watersheds were high or moderate intactness (>60%)
- Tributary riparian management areas had poorer condition than lakeshores for Buffalo, Gull, Sylvan Lakes
- Lakeshore had poorer condition than tributaries for Pigeon Lake
- Comparison of lakeshore maps between 2008 and 2017 indicate improvement over time
